STORIES of New Jersey

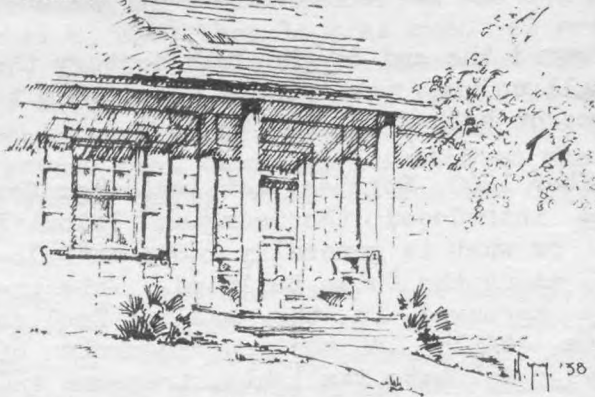
~ THE EAVES BECOME A STOOP ~
Drinkerhoff House

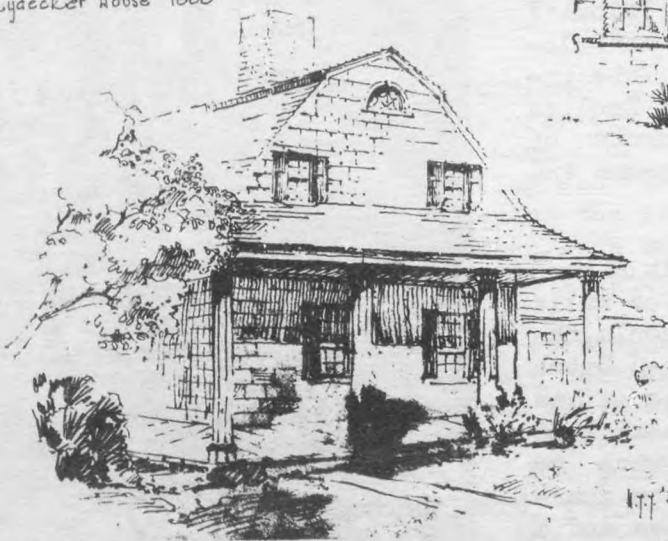
~ EAVES SOMETIMES TURN THE CORNER ~
Lydecker House 1603
